Hobomock Pond Hydrilla (*Hydrilla verticillata*) Management Program

Project Completion Report for 2013 Hydrilla Management Performed at Hobomock Pond – Pembroke, MA

March 2014

Aquatic Control Technology, Inc.
11 John Road
Sutton, MA 01590

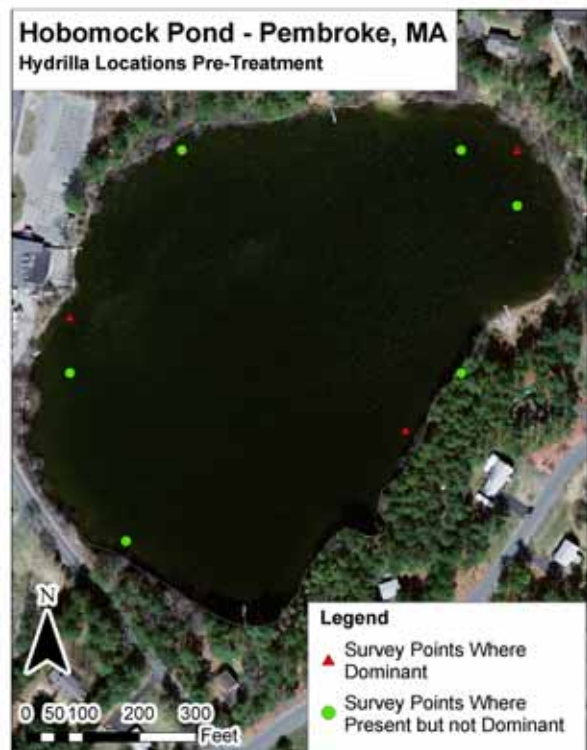
Figure 2 – 2013 Hydrilla Distribution Map

- Hydrilla was present at 9 of the 57 survey points, which is less than half of the 2011 and 2012 surveys
- Hydrilla was the dominant vegetation species at three of the survey points sampled.
- The overall submersed vegetation density in the pond has roughly stayed the same with a density of 2.0. This is similar to 1.9 and 2.1 in 2011 and 2012, respectively
- The percent occurrence of hydrilla was approximately 16%, which is a reduction from roughly 52% observed in 2009 pre-treatment.
- At the time of the Pre-Treatment Survey the overall plant assemblage consisted of eight submersed species and two emergent species. Of the eight submersed species, stonewort

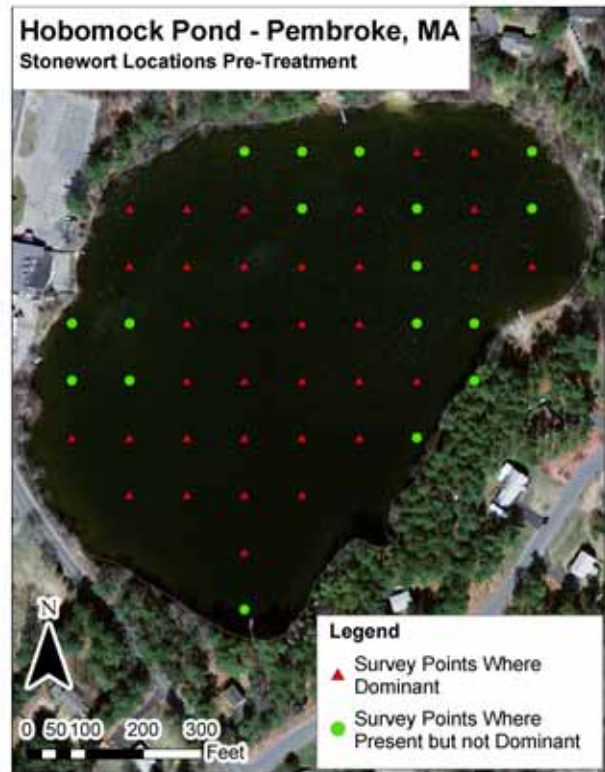
Figure 3 – 2013 *Nitella* Distribution Map

(*Nitella sp.*) was the most abundant, being present at 53 of the 57 data collection points (93%) and was dominant at 36.

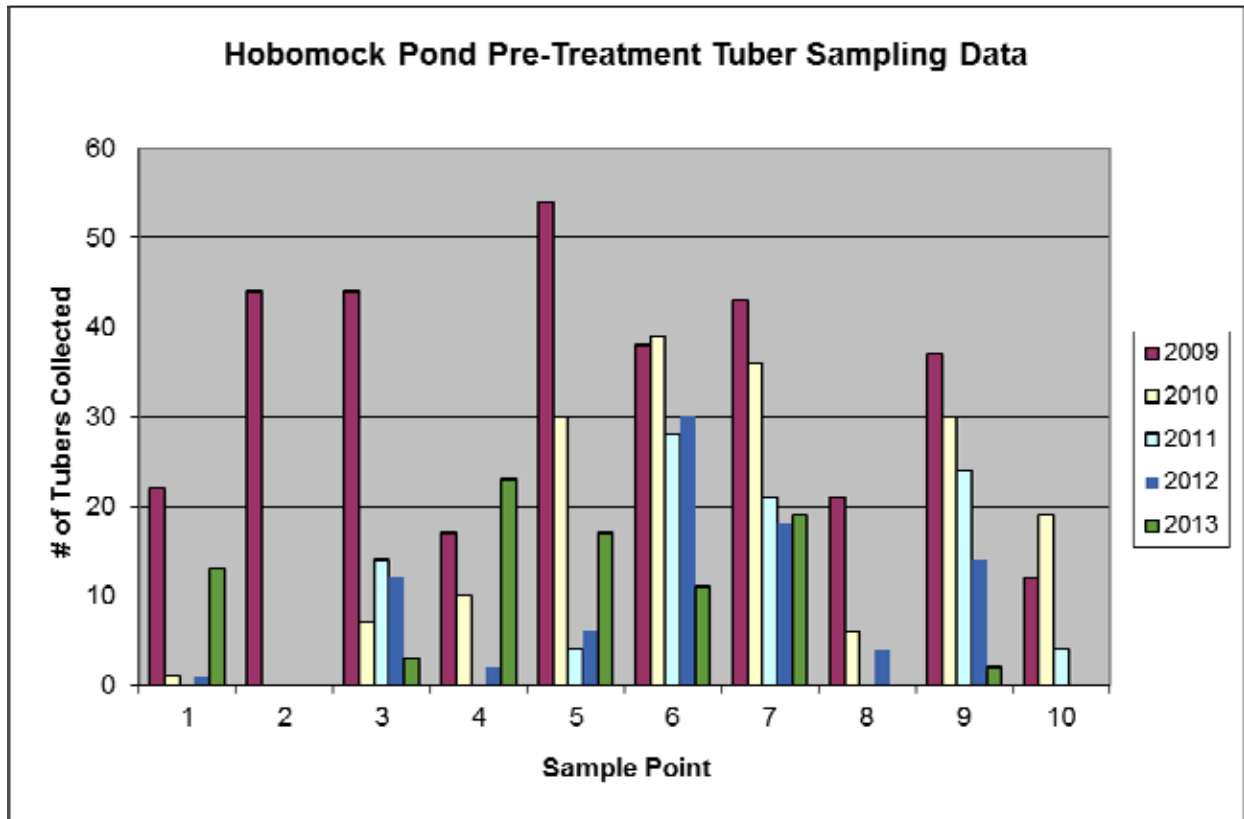
- Pre-treatment tuber density was 8.8 tubers/m².
- The sampling results continue to show an effective reduction in tuber numbers and density on an annual basis.
- Three sampling sites showed a slight increase in tuber numbers from 2011 to 2012. This is likely not the result of successful tuber production in 2011, but more likely the result of sampling variability. These sampling results are not intended to provide statistically significant data but is rather an index on which to assess management efficacy.

The tuber sampling protocols established in 2009 were again replicated at the time of the pre-treatment survey. The Ten point intercept data collection points (sites 1, 3, 7, 8, 15, 16, 32, 38, 47, 52) were sampled using a modified post-hole type digger. Ten replicate sediment samples, representative of the upper 4-6 inches of soft sediment, were collected from an approximate one square-meter area (100 total samples). Each sediment sample was then strained on site to extract viable hydrilla tubers and/or turions. The results are provided below.

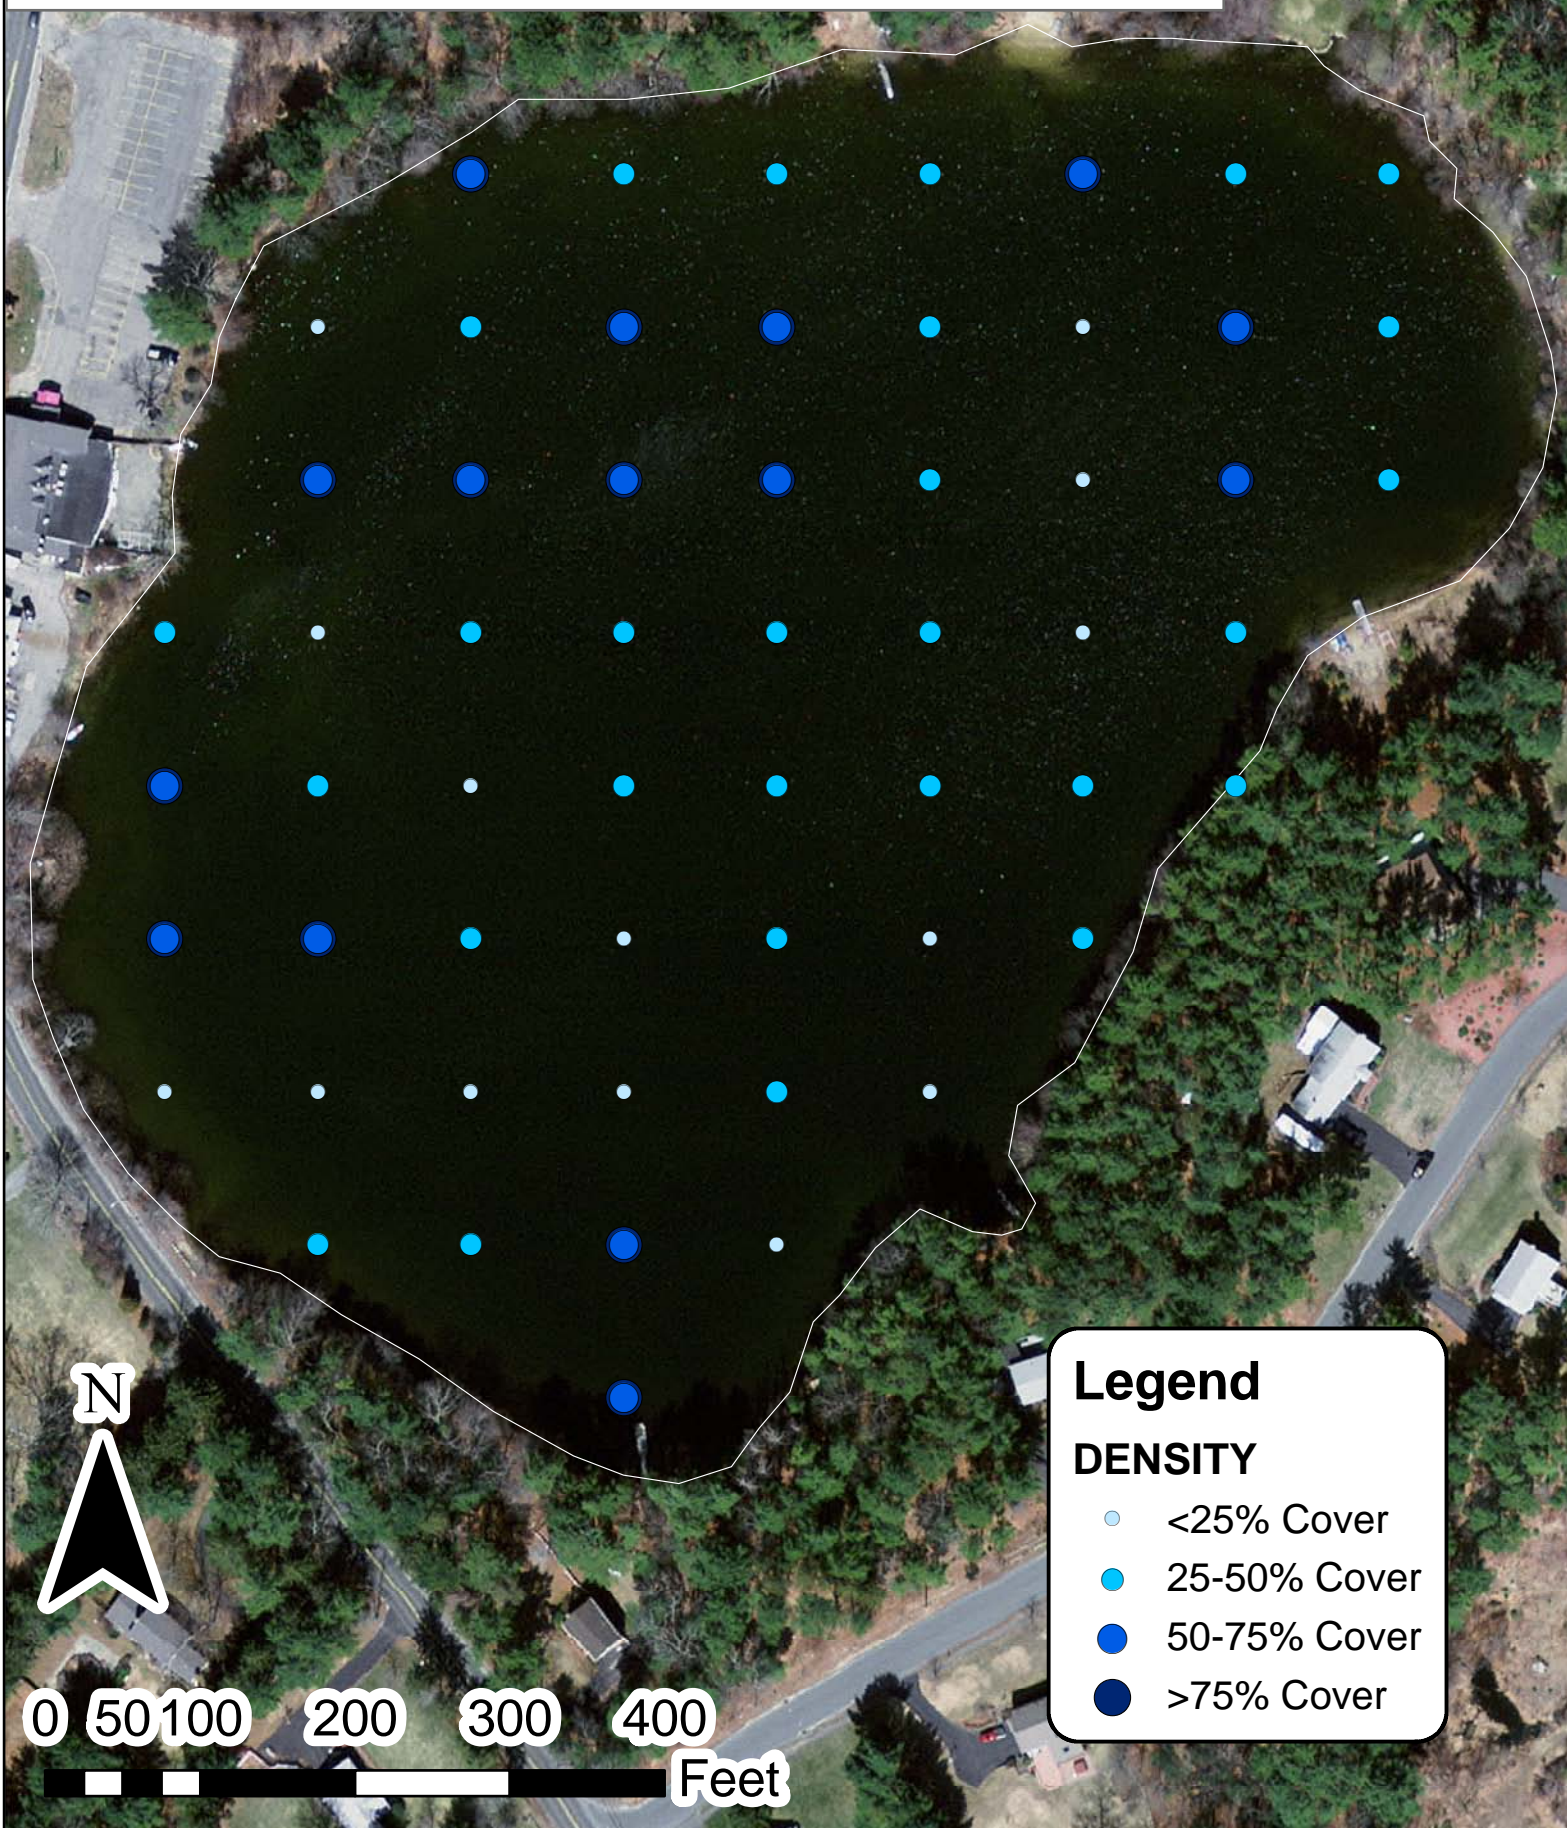
Plant Density Pre-Treatment

- <25% Cover
- 25-50% Cover
- 50-75% Cover
- >75% Cover
